# Artelon® Tissue Reinforcement Repair of Achilles tendon re-rupture

## Case report

Surgery performed on March 20th, 2007 by Jan Lidström, M.D. Ph.D., Consultant orthopedic surgeon, Department of Orthopedic Surgery, Sahlgrenska University Hospital Mölndal, Sweden.

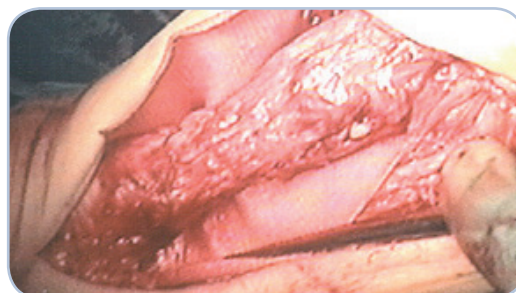
Image 1. The Artelon® Tissue Reinforcement was wrapped around the repaired tendon.

The Artelon® Tissue Reinforcement implant (ATR, 6 cm × 9 cm) was wrapped around the repaired tendon and was attached both distally and proximally to achieve correct tension of the tendon. The ATR was then fixed tightly to the tendon tissue using multiple, multidirectional sutures, (2-0 Vicryl) throughout both the implant and tendon (image 2).

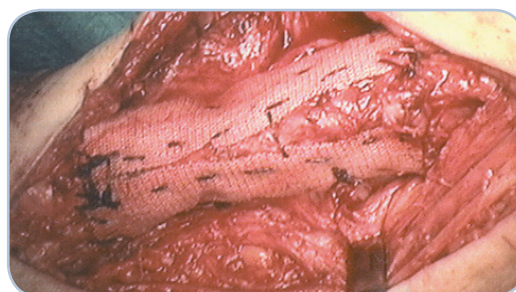
Image 2. The Artelon® Tissue Reinforcement was fixated to the tendon with sutures.
